FAILURE CAUSING DEFECTS IN CERAMICS: WHAT NDE SHOULD FIND

R. W. Rice, J. J. Mecholsky, S. W. Freiman, and S. M. Morey
Naval Research Laboratory
Washington, D. C.

The various types of defects causing failure in a variety of ceramic materials are illustrated. Examples are drawn from such ceramics as piezoelectric, infrared transmitting, and potential turbine materials. Both machining and processing defects are shown as sources of failure. The former are selected to illustrate the effects of machining parameters. Processing defects illustrated include pores, foreign particles and large grains, or clusters of these. Changes in the size of defects with specimen size are also noted.

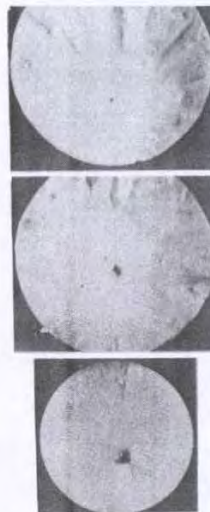
Figure 7. Failure of Al_2O_3 specimens from foreign particles (graphite). The upper two specimens' fracture surfaces are approximately 1/2 inch in diameter while the lower one is approximately 0.2 inches in diameter. These particles most likely occurred due to spallation from the graphite dies used in hot pressing.

Less common, but nonetheless important failure-causing defects are foreign particles such as the graphite and SiO_2 particles illustrated in Figs. 7 and 8. A single large grain or a cluster of large grains (e.g., as illustrated in Fig. 9) can also be important sources of failure provided they are associated with some other defect. Frequently, large grains are the result of a compositional inhomogeneity in the material (i.e., either a localized impurity or a deficiency or excess of additive material, which may be the direct source of the defect associated with the large grains), or may indirectly lead to this due to the generation of porosity. Large grains on the surface are usually preferential locations for failure-causing machining flaws discussed later and stresses from compositional inhomogeneities may aid in the formation of machining flaws.

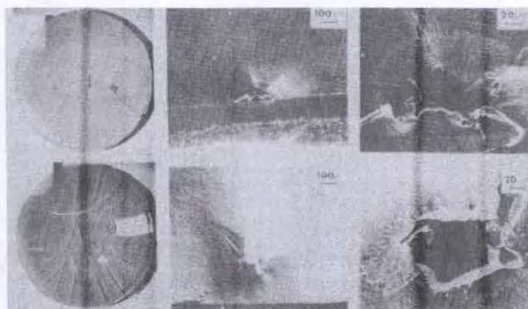
Figure 8. Failure of hot pressed MgF_2 infrared optical material from foreign particles (SiO_2). The upper series of photos from left to right show first a low magnification picture of an approximately 3" diameter test disc after fracturing under biaxial flexure. The photos to the right of this one show the fracture origin at two different magnifications. Note the foreign particle and the crack that had propagated upward from it as well as a crack that had propagated down onto the tensile surface as well as some associated porosity. The lower series of figures is another higher strength disc failing from a smaller particle that was not located as close to the tensile surface.

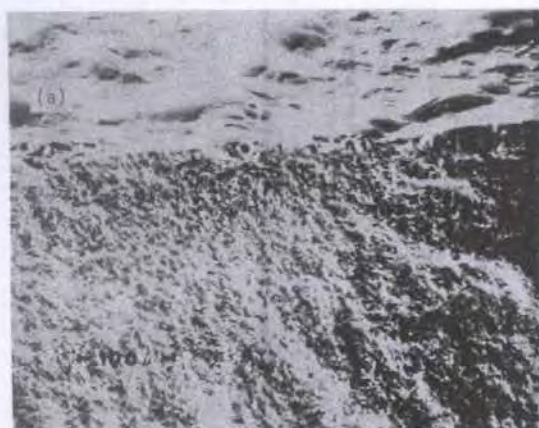
Figure 18. Fracture initiation in experimental hot pressed Si_3N_4 (+ 2 W/O ZrO_2 used as a hot pressing aid). The fracture initiating region is shown at lower magnification in the upper photo and higher magnification in the lower photo. It is relatively common to observe one or more pores in the oxide layer in the vicinity of fracture initiation as seen in this photo of a specimen which has been oxidized for 100 hours at 1250°C . Again, the oxide layer has consumed more than the thickness of the original layer containing machining flaws.

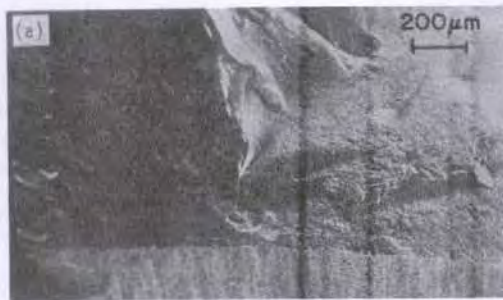
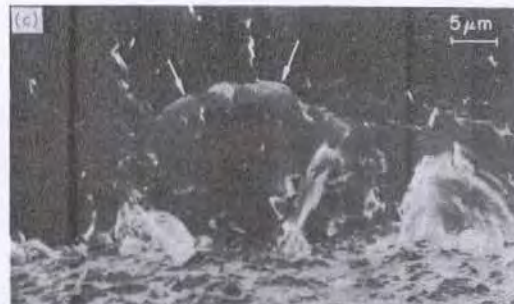
Figure 20. Effect of specimen size on machining. These three figures show progressively higher magnifications of a machining flaw (arrows) resulting from machining parallel with the specimen and tensile axis of a small flexure bar having approximate cross-sectional dimensions of .1" by .2". The failure stress of this hot press B₄C specimen was approximately 61,000 psi. Contrast this with the larger bar machined in the same fashion from the same material in Fig. 21.
